Manhole Inspection Summary

Manhole # S49W1_014MH

Location Address: **3214 Tate St.**

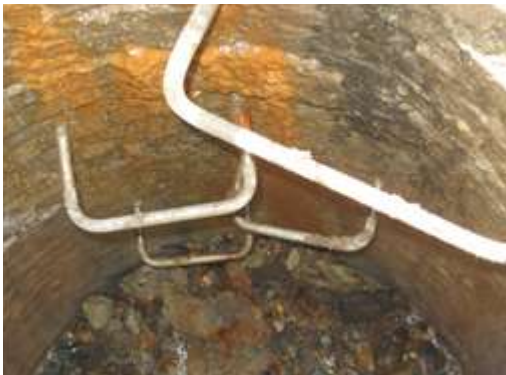
Defect 1

Frame Offset: **10** (in.) Condition: ☒ Sound ☐ Cracked ☐ Leaks

Frame Offset

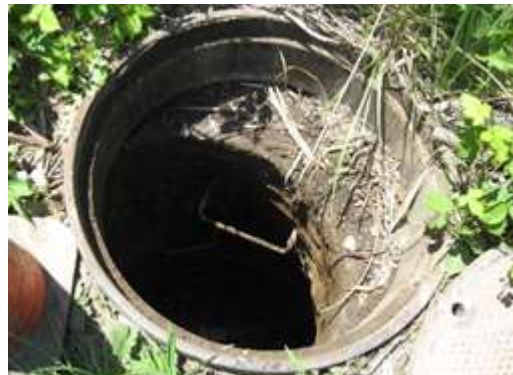
Defect 3

Frame above the grade

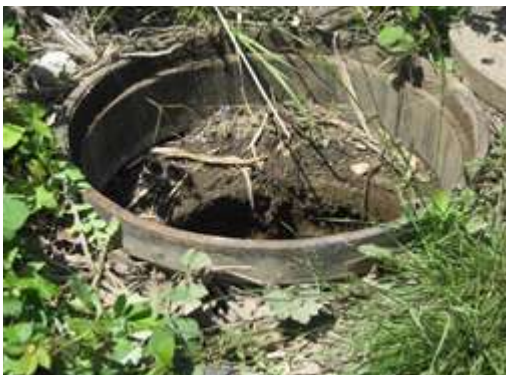
Defect 2

Condition: ☐ Sound ☒ **Cracked** ☐ Root Intrusion ☐ Loose Brick ☐ Deteriorated

Infiltration: ☐ None ☒ **Joint** ☒ **Cracks** ☐ Mortar ☐ Roots ☐ Wall

Crack and infiltration

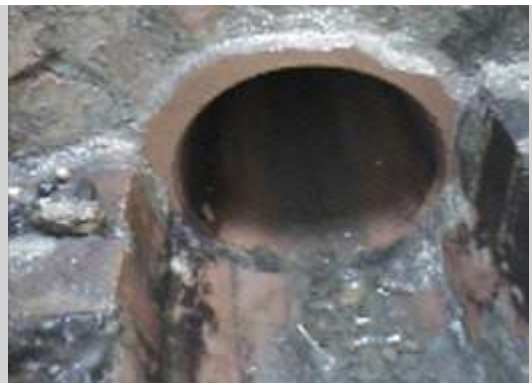
12 O'Clock Outflow

Pipe Height: **8.4** (in.) Rod and Bar (Angled)
Pipe Material: **Clay** ☐ Pipe Lined
Invert Depth: **9.30** (ft.) Flow Characteristics: **Slow**
Deposits: ☒ None ☐ Mud ☐ Sludge ☐ Debris ☐ Grease
Silt Depth: **1** (in.) Deposits Extent: **Light**
Infiltration: **None** Pipe Seal Cond: **Sound**

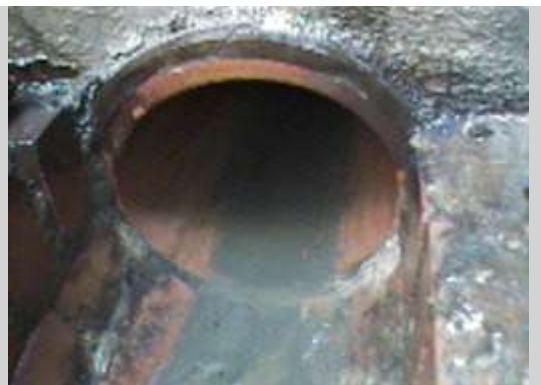
6 O'Clock Inflow

Pipe Height: **8.4** (in.) Rod and Bar (Angled)
Pipe Material: **Clay** ☐ Pipe Lined
Invert Depth: **9.20** (ft.) Flow Characteristics: **Slow**
Deposits: ☒ None ☐ Mud ☐ Sludge ☐ Debris ☐ Grease
Silt Depth: **2** (in.) Deposits Extent: **Light**
Infiltration: **None** Pipe Seal Cond: **Sound**
